6th European Conference on  
**ECOLOGICAL RESTORATION**

Programme and  
 Abstract Book

## A GEOMORPHIC APPROACH FOR THE ECOLOGICAL RESTORATION OF KAOLIN MINES AT THE UPPER TAGUS NATURAL PARK (SPAIN)

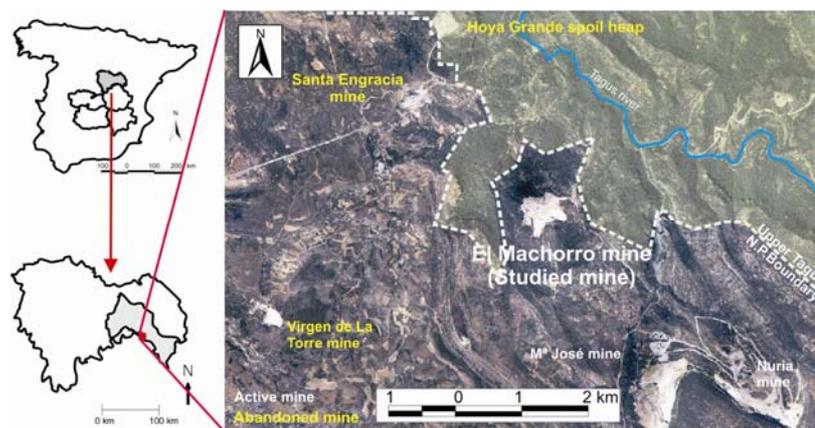
Figure 1. Kaolin mines location at the edge of the Upper Tagus Natural Park (Guadalajara province of Spain).

The Upper Tagus Natural Park is located in the Eastern Guadalajara province of Spain (Fig. 1). In this area, a spatial coincidence of extraordinary natural resources takes place. On the one hand, exceptional kaolin deposits occur within sediments of the Upper Cretaceous strata (Utrillas Formation). 30% of the kaolin production of Spain comes from this area, being mining the second economic activity here (13.5 % of the local employment). On the other hand, this portion of land supports unique bio and geodiversity in Spain, with distinctive aquatic ecosystems (a Natural Park and two protected habitats of the Natura 2000 network).

The main source of sediments from the surroundings of the Natural is located at the abandoned mines (such as Santa Engracia), by the Peñalen village (Fig. 1). These abandoned mines have not any restoration measurements, As far as active mines are concerned, with reclamation plans, they also have the potential of delivering sediments
